# REFURBISHMENT PROTECTIVE COATINGS FOR CONCRETE

# SIKA – YOUR PARTNER

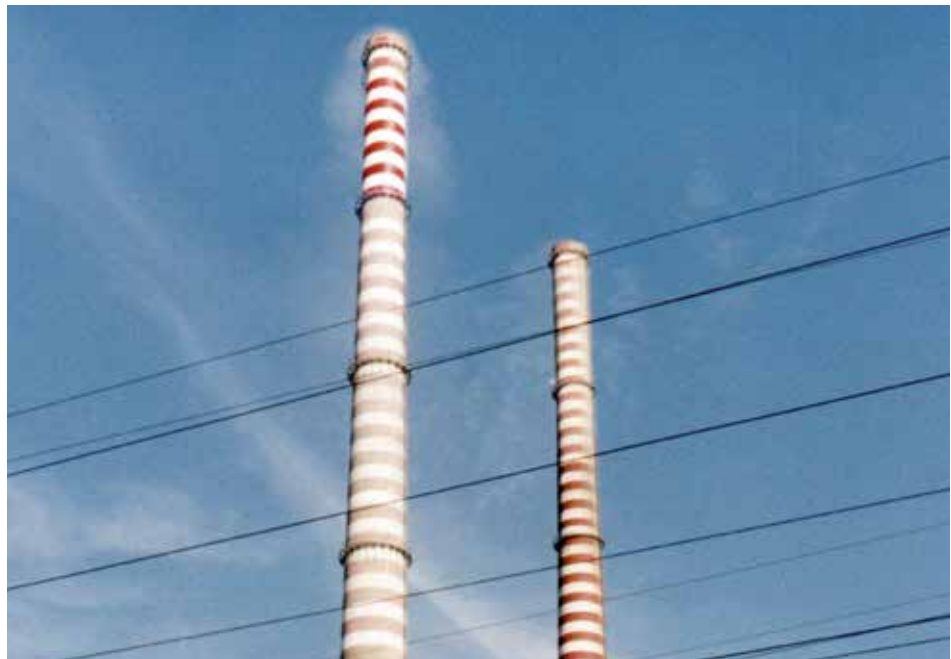
Chimneys in direct sunlight indicating variations in thermal exposure which are further exacerbated by the effects of the downward flow of hot exhaust gases during periods of temperature inversions.

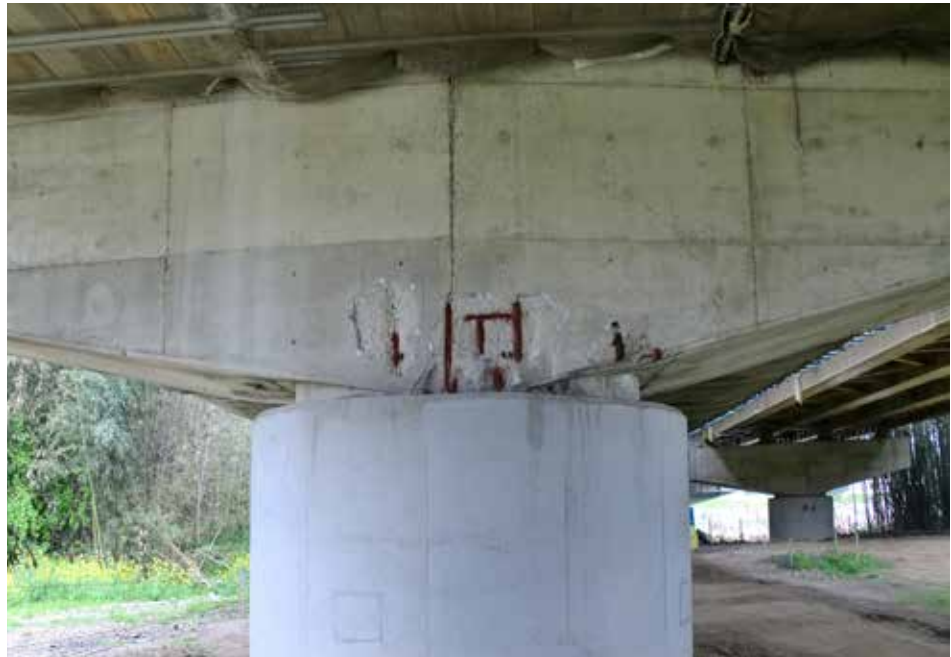
General corrosion induced by carbonation aggravated with low concrete cover issue.

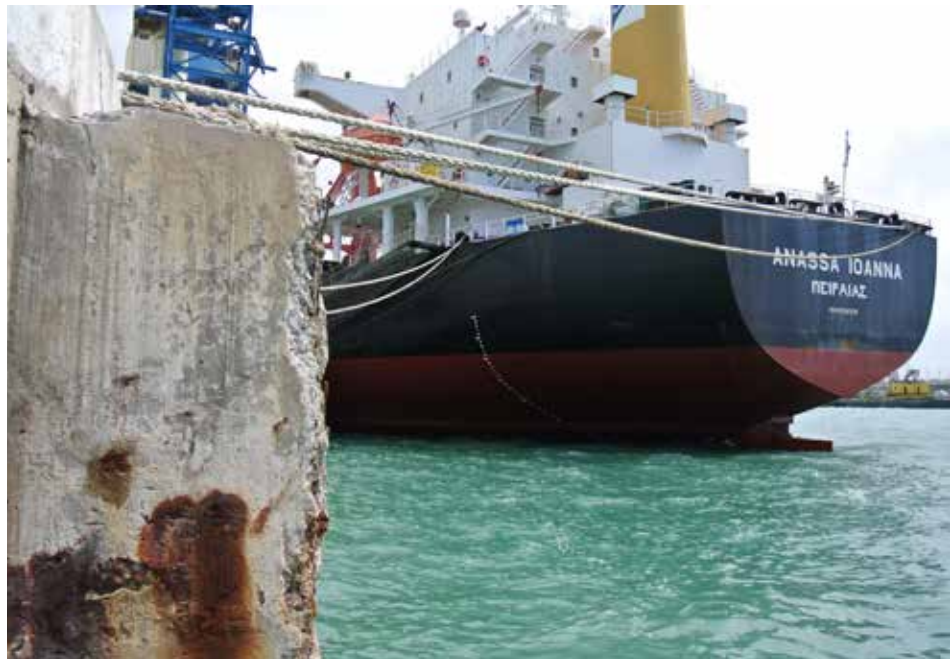
Reinforcing steel corrosion in a pier.

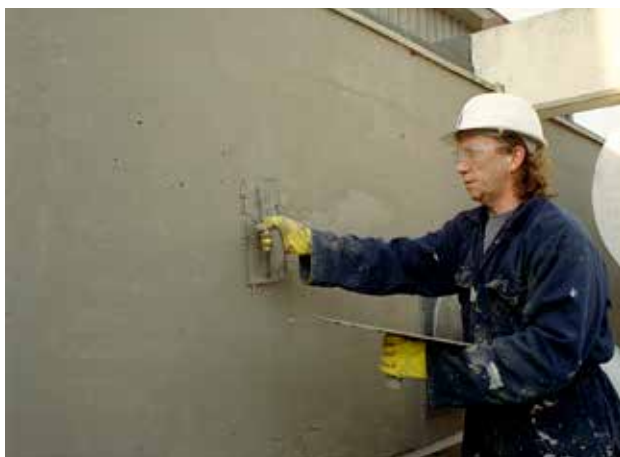
Sika MonoTop®-723 N: resurfacing mortar for hand and spray application.
